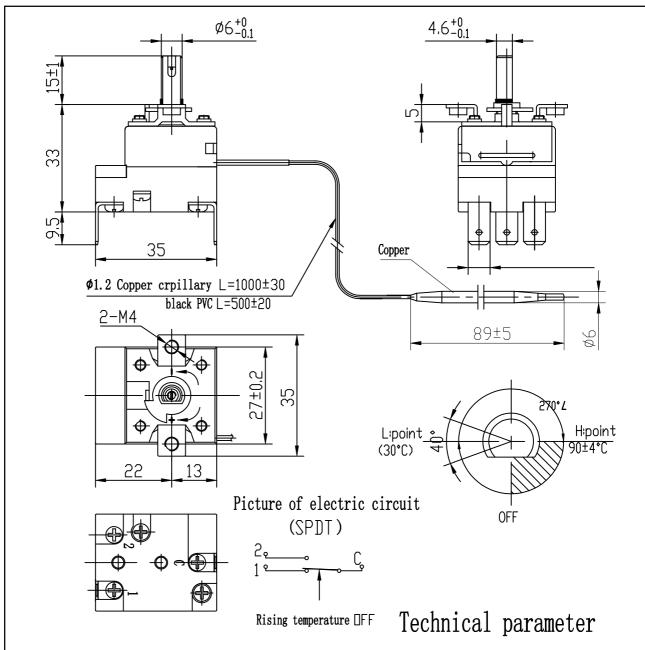
- 1. The picture shows that the adjusting axle is on the H point;
- 2. The thermostat's capillary tube and the temperature sensing bulb are easy to damage, They couldn'd be damaged\pressed to flat/broke off, or it will influence the thermostat's function and temperature;
- 3. Thermastat's working temperature is 25°C, the capillary tub must be immersed in heat water of 30 \sim 80mm deep, or the testing result will not be correct;
- 4. Testing condition:the model of temperature variety is $\leq 1^{\circ}$ C/lmin.

- 1.H point temperature/OFF:90±4°C DIFF: 5±3°C
- 2.The fixing electric voltageAC250V
 The fixing electric current16A
- 3.Electrical strength: 2000VAC/1min/0.5mA
- 4. The touching electric resistance <50m Ω
- 5. Insulating electric resistance >100 M Ω
- 6. The highest temperature the main body can endured: 125° C
- 7.The hignest temperature the temperature feeling tube can endured:120° C
- 8.Product's life:>10 times
