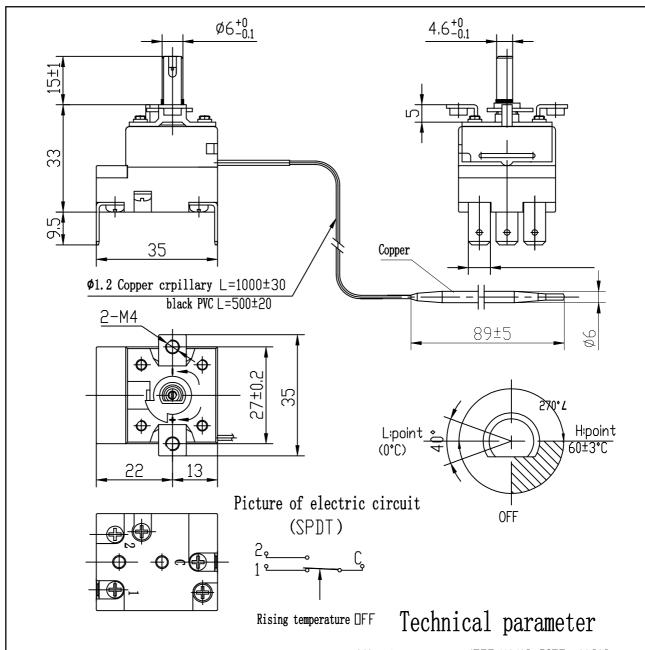
- 1. The picture shows that the adjusting axle is on the H point;
- 2. The thermostat's capillary tube and the temperature sensing bulb are easy to damage, They couldn'd be damaged\pressed to flat/broke off, or it will influence the thermostat's function and temperature;
- 3. Thermastat's working temperature is 25°C, the capillary tub must be immersed in heat water of 30 \sim 80mm deep, or the testing result will not be correct;
- 4. Testing condition:the model of temperature variety is $\leq 1^{\circ}$ C/lmin.

- 1.H point temperature/DFF:60±3°C DIFF: 4±2°C
- 2.The fixing electric voltageAC250V
 The fixing electric current16A
- 3.Electrical strength: 2000VAC/1min/0.5mA
- 4. The touching electric resistance <50m Ω
- 5. Insulating electric resistance >100 M Ω
- 6.The highest temperature the main body can endured:125°C
- 7.The hignest temperature the temperature feeling tube can endured:90° C
- 8.Product's life:>10 times
