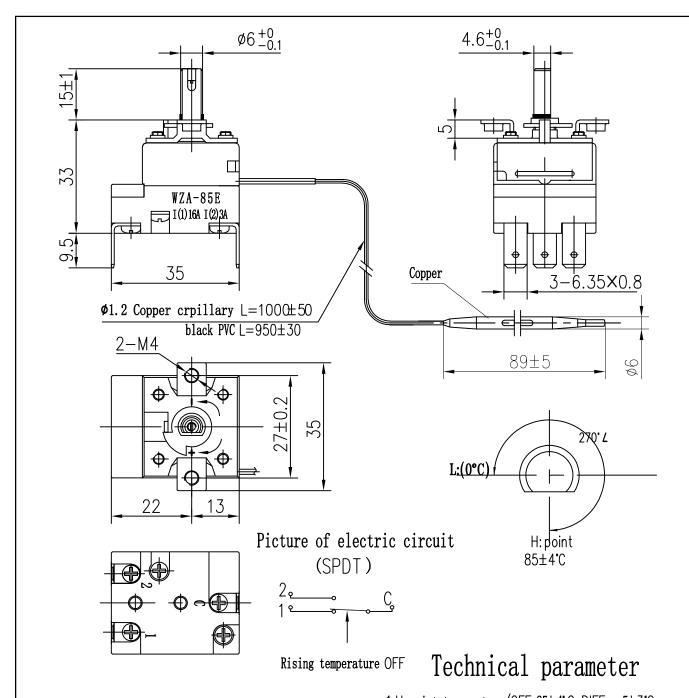
- 1. The picture shows that the adjusting axle is on the H point;
- 2. The thermostat's capillary tube and the temperature sensing bulb are easy to damage, They couldn'd be damaged\pressed to flat/broke off, or it will influence the thermostat's function and temperature;
- 3. Thermastat's working temperature is 25°C, the capillary tub must be immersed in heat water of 30~80mm deep, or the testing result will not be correct;
- 4. Testing condition: the model of temperature variety is ≤1°C/1min.

- 1.H point temperature/OFF:85±4°C DIFF:5±3°C
- 2. The fixing electric voltage: AC250V The fixing electric current: 16A
- 3.Electrical strength: 2000VAC/1min/0.5mA
- 4. The touching electric resistance: <50m $\Omega$
- 5. Insulating electric resistance: >100M Ω
- 6. The highest temperature the main body can endured: 125°C
- 7. The hignest temperature the temperature feeling tube can endured: 120° C
- 8.Product's life:>100.000 times
