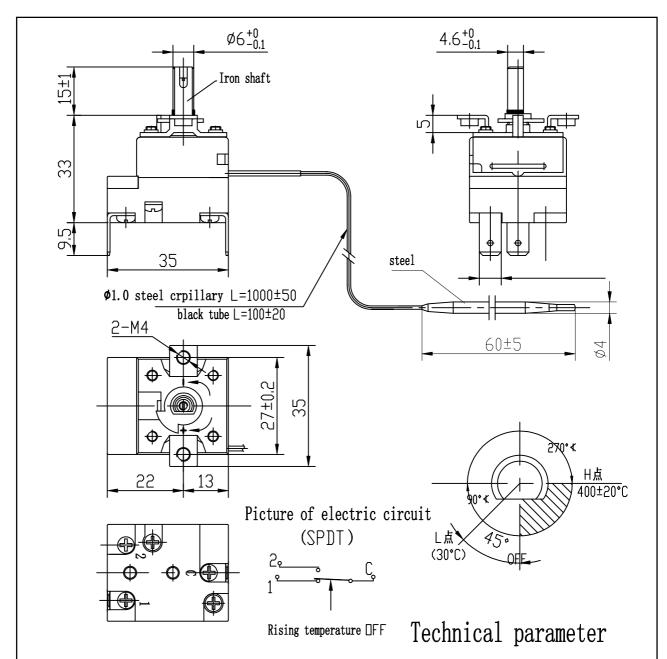
- $1. \ \mbox{The picture shows that the adjusting axle is on the H point;}$
- 2. The thermostat's capillary tube and the temperature sensing bulb are easy to damage, They couldn'd be damaged\pressed to flat/broke off, or it will influence the thermostat's function and temperature;
- 3. Thermastat's working temperature is 25°C, the capillary tub must be immersed in heat water of 30 \sim 80mm deep, or the testing result will not be correct;
- 4. Testing condition: the model of temperature variety is ≤ 1 °C/lmin.

- 1.H point temperature/DFF: $400\pm20^{\circ}$ C DIFF: $8\pm5^{\circ}$ C
- 2.The fixing electric voltageAC250V The fixing electric current16A
- 3.Electrical strength: 2000VAC/1min/0.5mA
- 4. The touching electric resistance <50 m Ω
- 5. Insulating electric resistance >100 M Ω
- 6. The highest temperature the main body can endured: 125 ${\tt C}$
- 7.The hignest temperature the temperature feeling tube can endured:350°C
- 8.Product's life:>10万次
